## Theme: Elimination of Automatic Censor Lights Which Fail to Light Up at Night

| OFFICE LOCATION: | Instrument section, test center, distribution department. | | |
| PRESENTER: | Chosaki Koichi | Circle name: | Double Power |

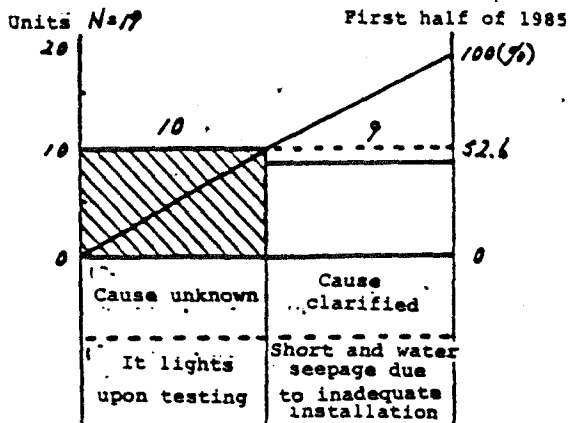
Investigation of automatic censors that lead to non-lighting units

52.6 % of the non-lighting unit cases examined are of unknown causes

So many cases of unknown cause; it poses quite a problem.

Based on the results of investigation, business office is notified of necessary steps

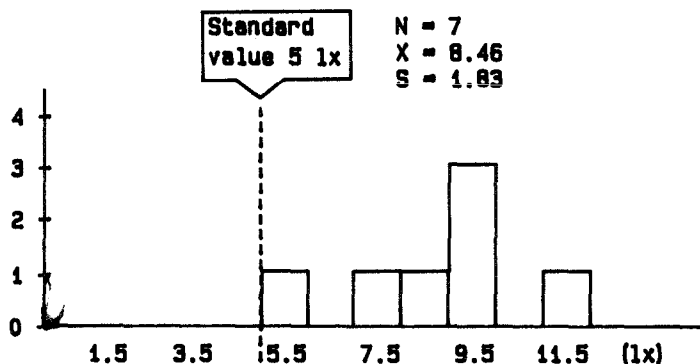
Experimental condition No. 1  
(Incandescent lamp)

Non-lighting units made by Company A

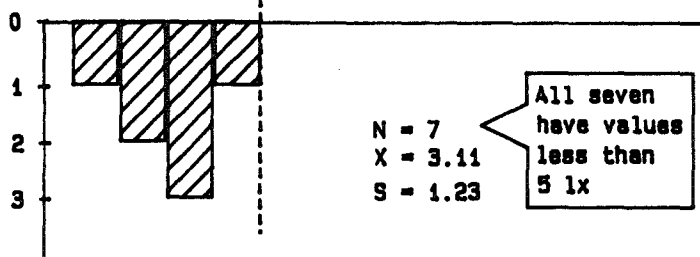
Experimental condition No. 2  
(Fluorescent lamp)

C (electric lamp) is significant at 5% level, when others are not. Fluorescent lamp results in lower lighting illumination

The use of automatic sensor made by Company A and fluorescent lamp in an area with high night-time illumination results in failures, to light at night.

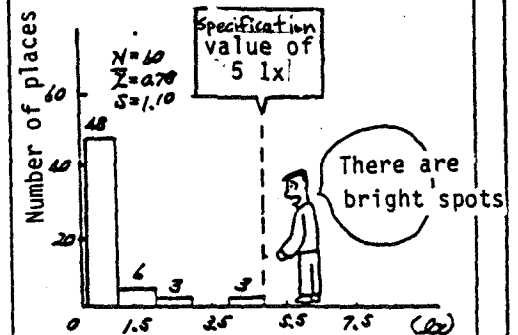
Each member of the team conducted measurements at ten different places in his neighborhood

There are some spots that are quite bright

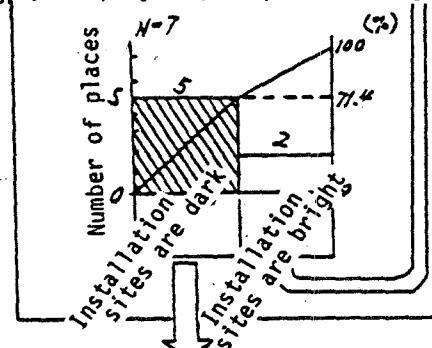
Survey of installation sites with non-lighting units made by Company A (Telephone survey)

Non-lighting occurs even when the surrounding illumination at installation sites are low

Reconsider the installation location (direction) of automatic censor (Sales Offices)

Reinstall the non-lighting units

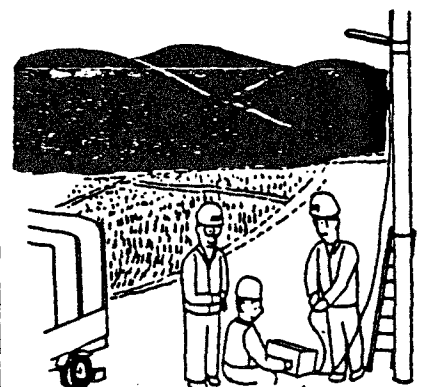
Fluorescent lamp and glow lamp made the non-lighting units made by Company A to light.

The automatic censor made by Company A is vulnerable to the effects of insufficient connections.

Visit the failure site and conduct on-site test

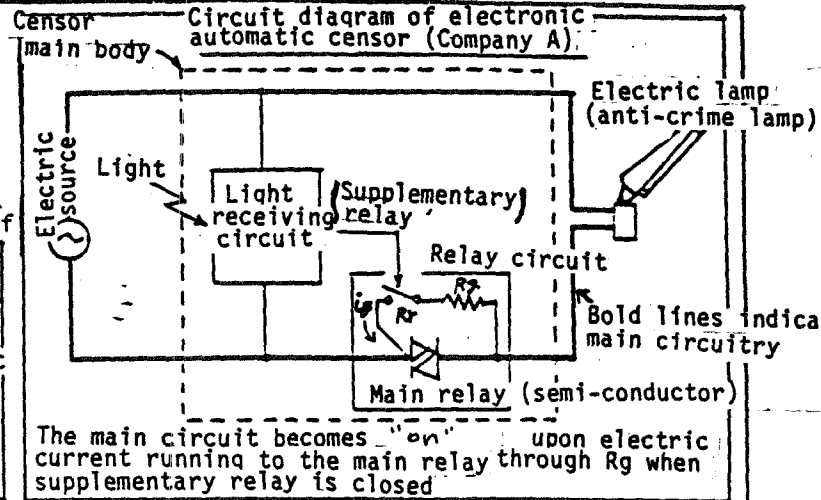
Measured resistance values of Rr and circuit closing characteristics of the main relay

Company A's automatic sensors with low relay sensitivity produce nocturnal failure to light when attached to fluorescent lamps with insufficient contact

Instructions were issued to "Refasten anti-crime fluorescent lamps and glow lamps and test the operation when night-time failure to light occurs with Company A's automatic sensors"

(Measure 1)  
To reduce the level of illumination --- modification in the design of light receiving circuitry  
(Measure 2)  
To cope with the insufficient sensitivity --- changes in the design of relays of main relay

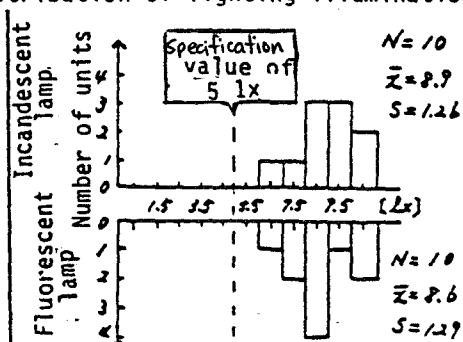
Distribution of lighting illumination

It was confirmed that with improved products there was no nocturnal failure to light.
