## MECHANICAL MAINTENANCE FUNCTIONAL TEAM

| TEAM PROJECT PLANNING WORKSHEET | | | | | | | | | | | | | |
|---|---|---|---|---|---|---|---|---|---|---|---|---|---|
| Theme<br>(Problem Area) | | Unit #3 Feedwater Heater Failures | | | | | | | | | | | |

IN THE PAST 9 YEARS THERE HAVE BEEN 22  
LOAD CURTAILING DIAPHRAGM FAILURES ON HEATER #1  
THESE FAILURES SHOULD BE REDUCED TO A POINT  
WHERE THEY MEET OUR EFOR TARGET

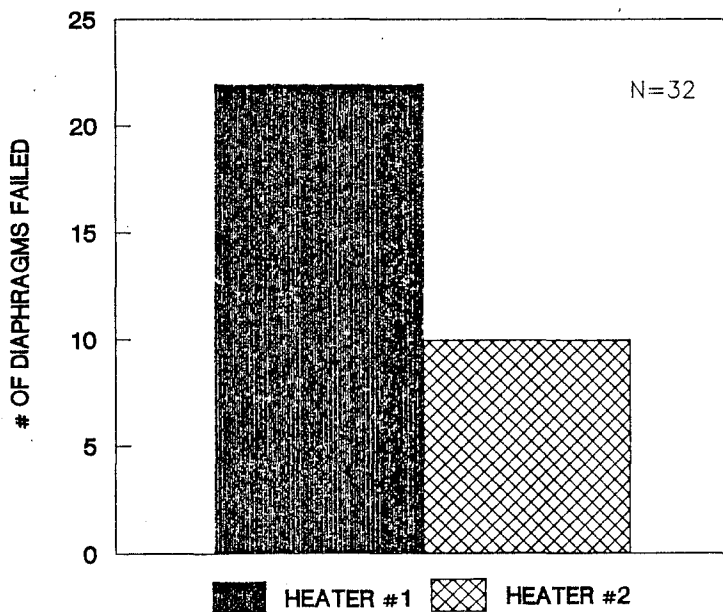
### PSN 3 HIGH PRESSURE F.W. HEATERS DIAPHRAGM FAILURES IN GEMS 1978 TO 1987

#1 HEATER IS HAVING MORE PROBLEMS WITH DIAPHRAGMS, SO LET'S INVESTIGATE WHAT IS WRONG WITH IT.

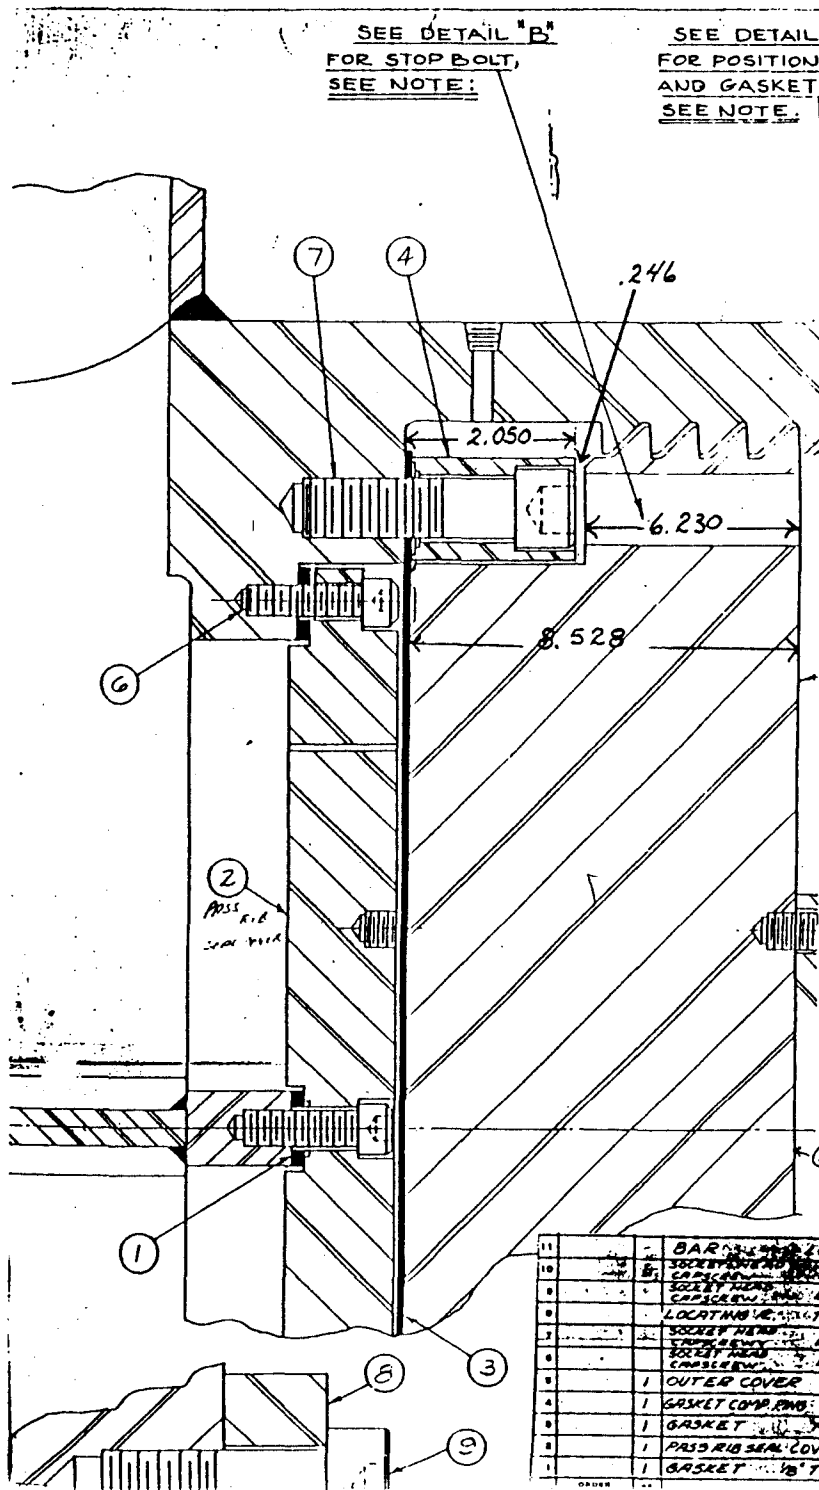
MEASUREMENTS WERE TAKEN 1-15-69 AND RECORDED ON PRINT BY CAT.

1. FLATNESS OF ITEM 4
2. ROUNDNESS OF ITEM 4
3. THICKNESS OF ITEM 4
4. WITH DEPTH GAUGE, CHECK FROM OUTSIDE OF ITEM 4 TO ITEM 3
5. CHECK ITEM 3 SEALING SURFACE ON NTR. BODY
6. CHECK DIMENSIONS OF ITEM 5
7. CHECK DEPTH OF ITEM 5 FROM END OF NTR. BODY BEFORE REMOVAL
8. CHECK ITEM 2 FOR Equalizing hole
9. CHECK THREADS ON PLUG & HEATER
10. PRESSURE TEST HEATER FOR TUBE LEAKS.
11. CHECK PROCEDURE FOR ASSEMBLY WHILE DISASSEMBLING.

★ THE TEAM FOUND SOME PROBLEMS IN THE HEATER, BUT NONE COULD BE RELATED TO DIAPHRAGM FAILURES

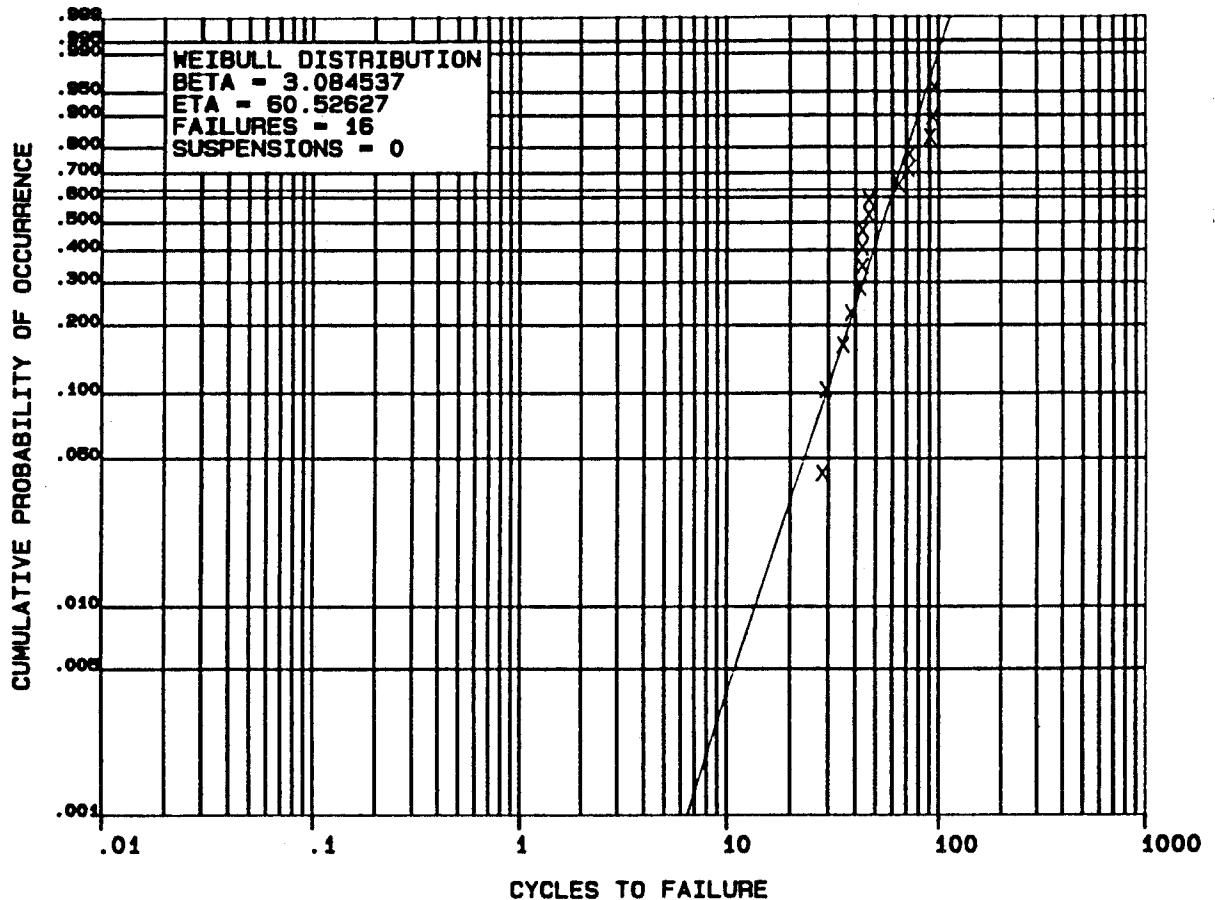
PSN UNIT 3 NO. 1 FWH  
DIAPHRAGM FAILURES

THIS WEIBULL SHOWS US THAT WITH DATA PROVIDED FROM 1980 TO 1987 THE AVERAGE FAILURE OCCURED AT 60.5 CYCLES. SO WE CAN SAY THAT AT 92 CYCLES WE ARE 95% CONFIDENT THERE WILL BE A FAILURE. ON 08/30/88 WHEN THE UNIT REACHED 59 CYCLES THE DIAPHRAGM ON #1 HEATER FAILED.

Called manufacturer's design engineer who said "because this was such a bad design problem PSN-3 had the only 2 diaphragm type heaters in the country.

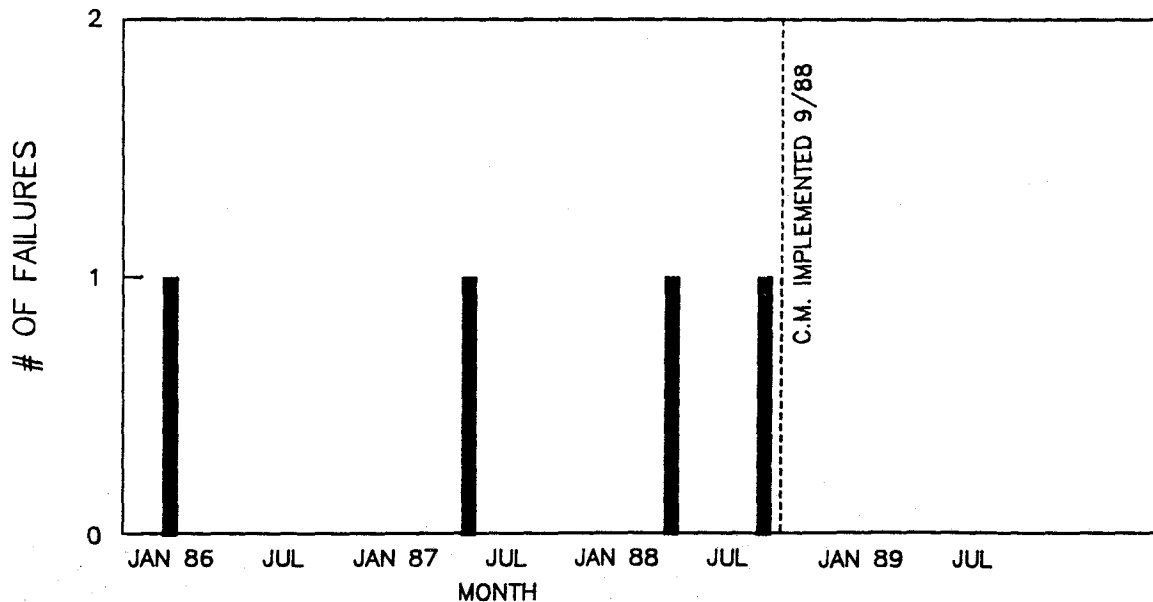
PSN UNIT 3 NO. 1 FEED WATER DIAPHRAGM FAILURES  
GEMS DATA 1/1/86 THRU 12/31/88

#1 F.W. HEATER HAS EXPERIENCED 94 CYCLES THIS YEAR, WITH 27 CYCLES SINCE INSTALLTION OF 2 DIAPHRAGMS. THE HEATER IS TO BE CYCLED TO FAILURE, AT THAT TIME THE TEAM WILL DETERMINE THE NUMBER OF CYCLES WHEN DIAPHRAGMS SHOULD BE CHANGED TO AVOID A FORCED OUTAGE.
