# FAULT TREE DIAGRAM ANALYSIS CONCERNING FRETTING MODE LEAKS DUE TO BAFFLE WATER JETS

## FMEA CONCERNING FRETTING LEAKS

**FMEA CONCERNING PINHOLE LEAKS**

# KANSAI PRESENTATION

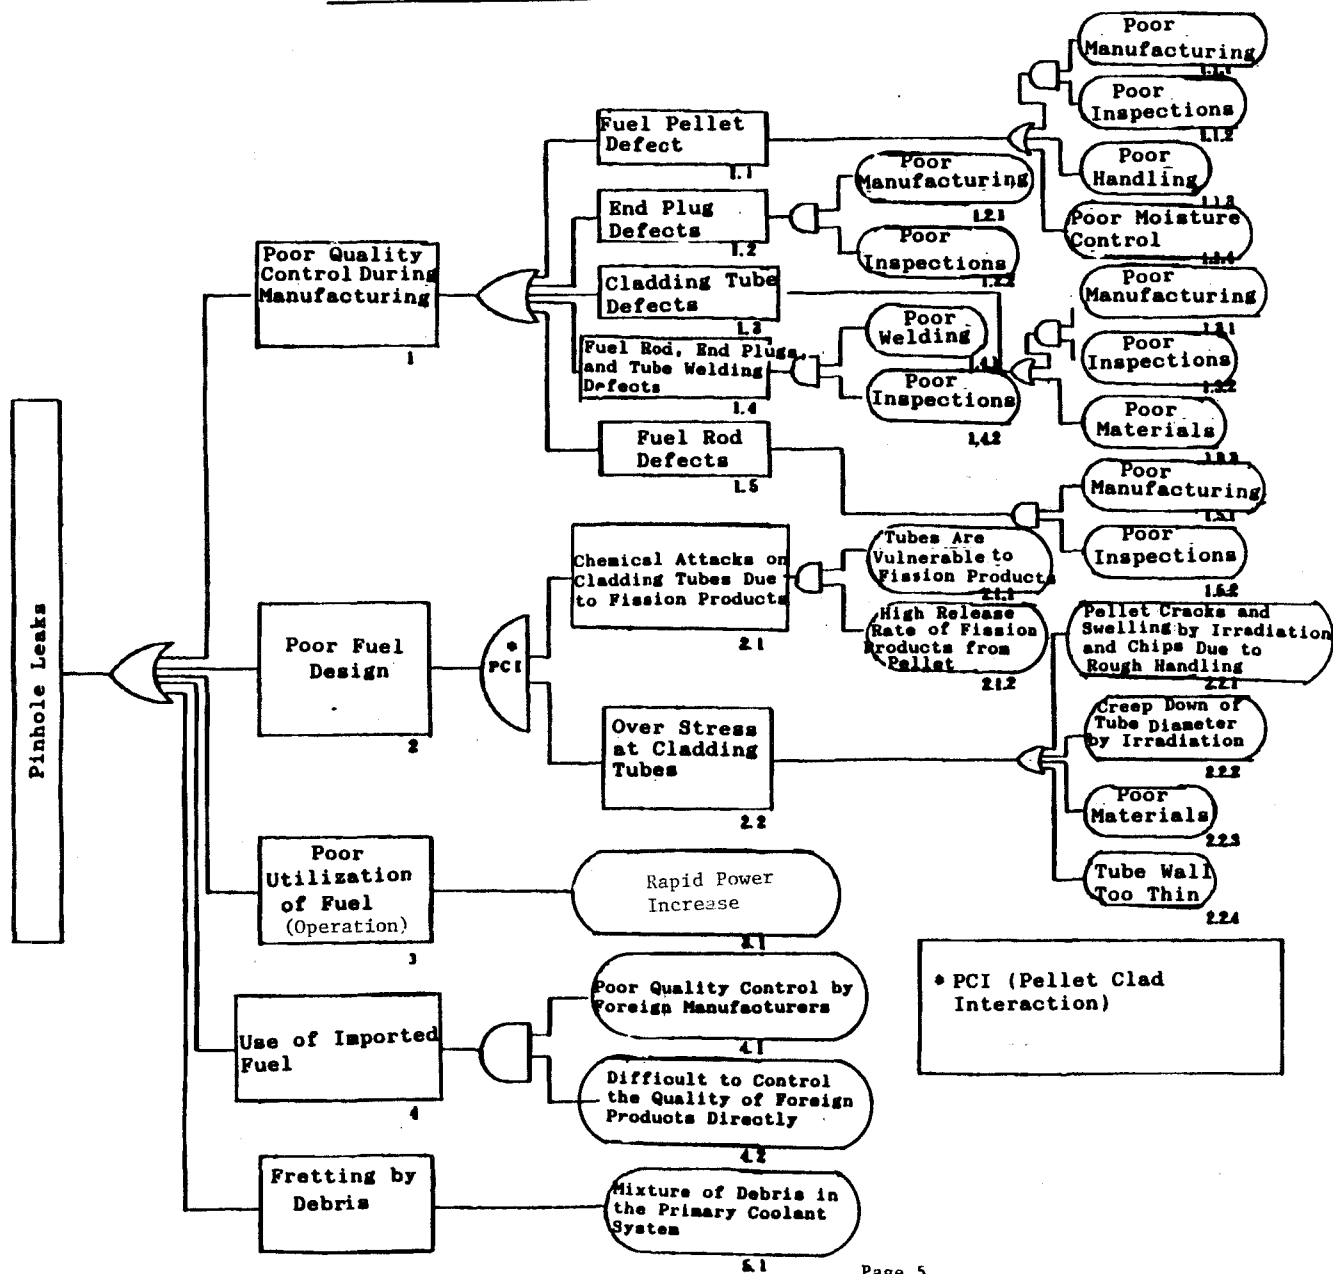
PINHOLE LEAKS FAULT TREE DIAGRAM

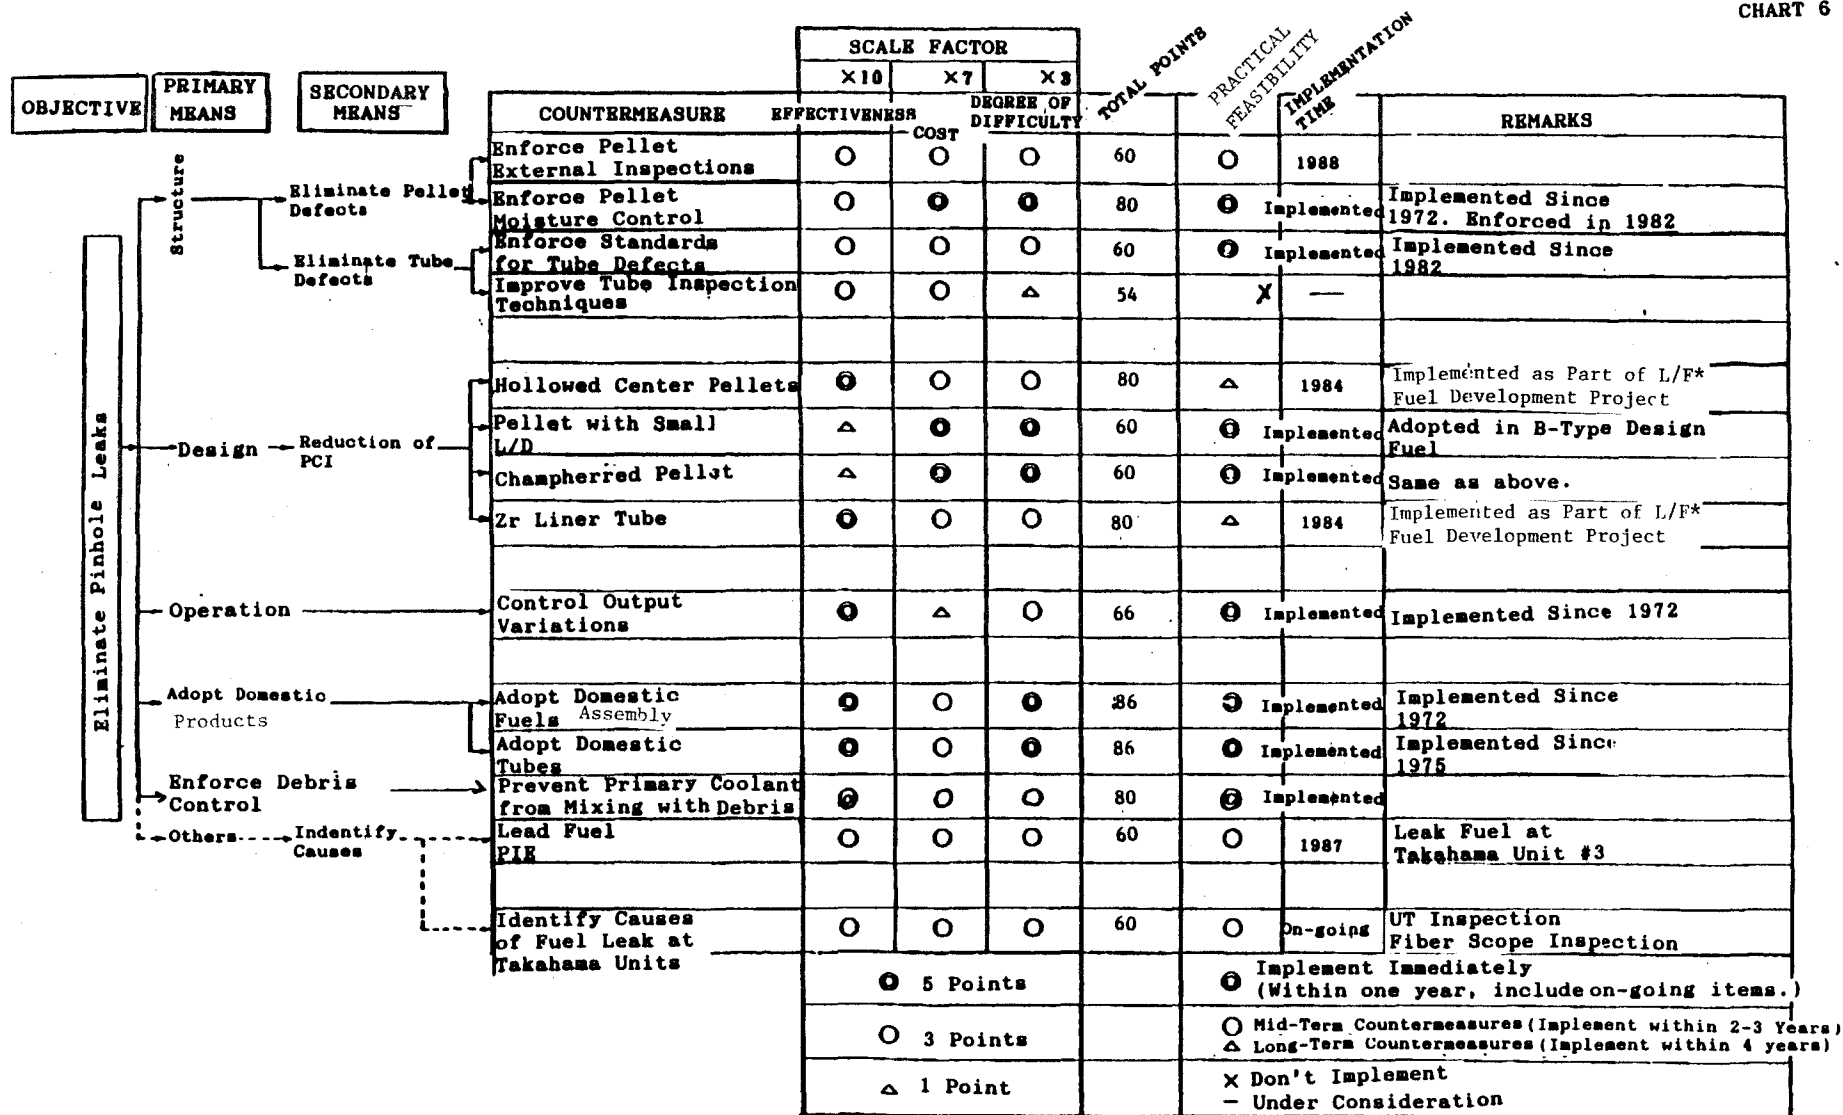
CHART 6

## PINHOLE LEAK COUNTERMEASURE TREE DIAGRAM

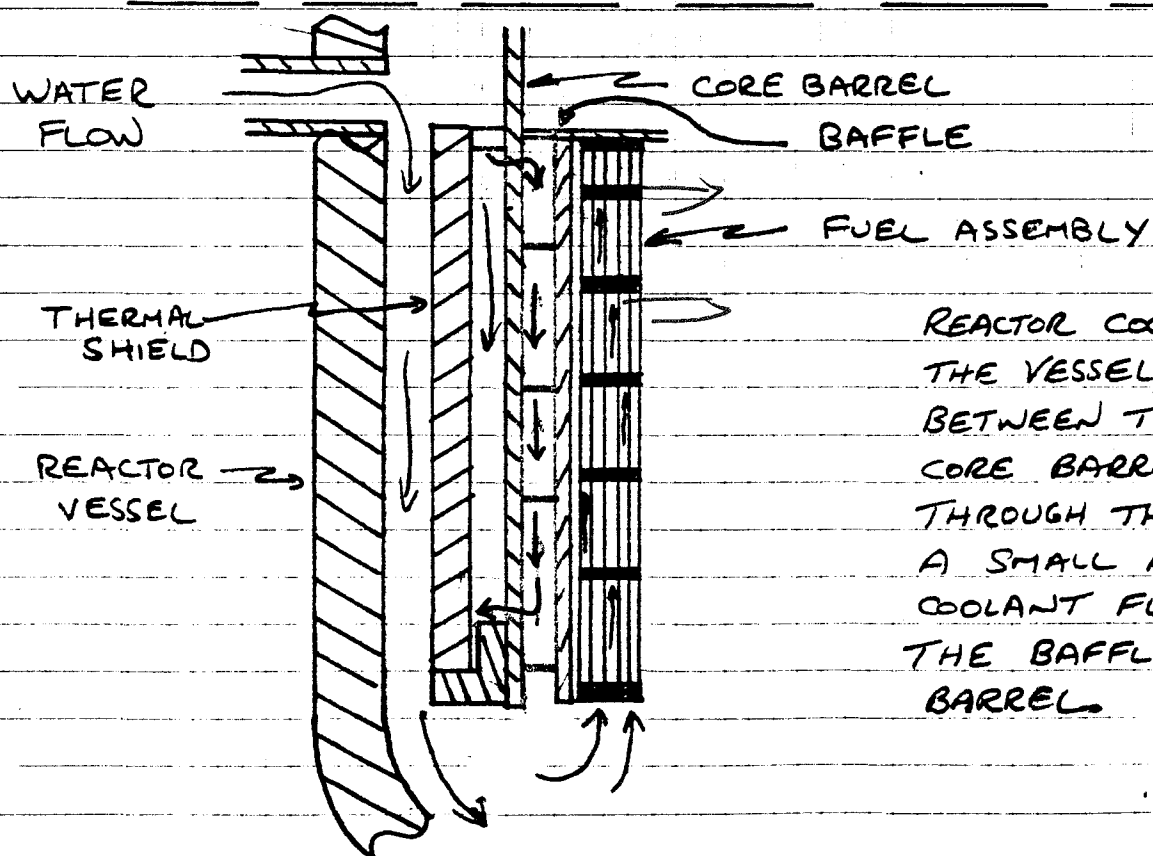
COOLANT FLOW - REACTOR CORE

REACTOR COOLANT ENTERS THE VESSEL, FLOWS DOWN BETWEEN THE VESSEL & CORE BARREL, THEN UP THROUGH THE FUEL ASSEMBLY. A SMALL AMOUNT OF COOLANT FLOWS DOWN BETWEEN THE BAFFLE AND CORE BARREL.
