# CASE: AIR LEAKAGE TO A POWER PLANT CONDENSER

## IDENTIFY AN IMPROVEMENT OPPORTUNITY

THE DAVIS POINT THERMAL POWER PLANT SUPPLIES UP TO 440 MEGAWATTS OF ELECTRIC POWER TO THE SINGLETON ELECTRIC + LIGHT COMPANY'S TRANSMISSION SYSTEM. (SEL)

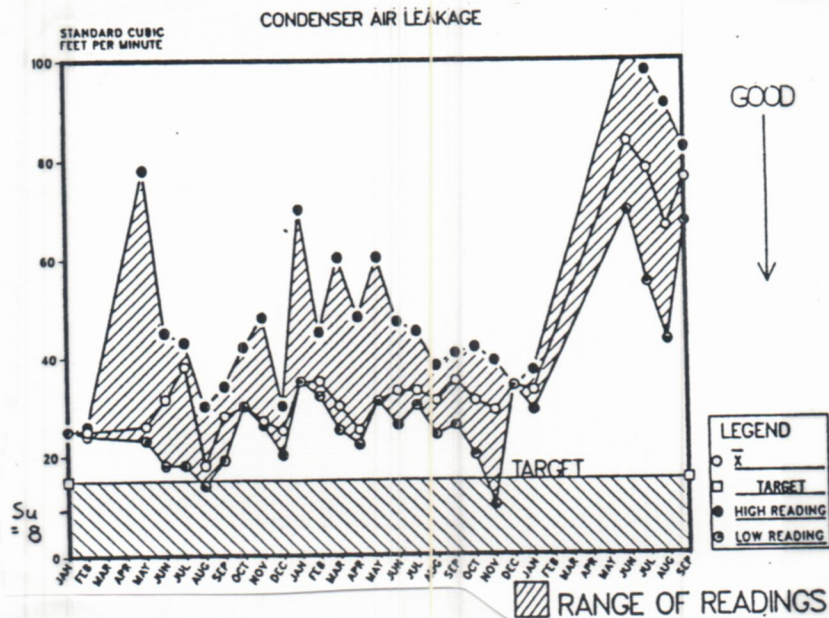
Air Leakage has been higher than the target and, recently, has been increasing

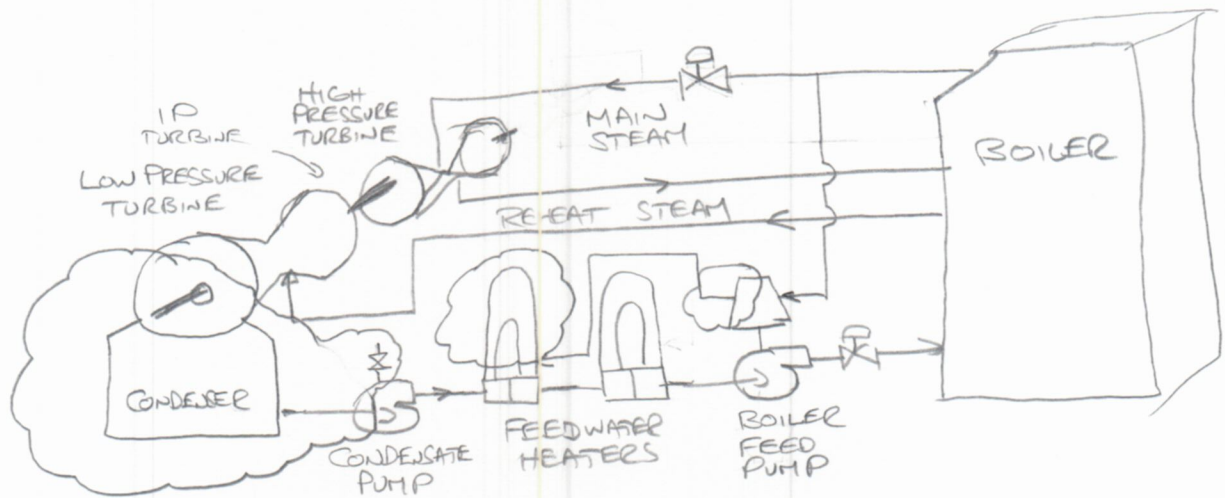
AIR INLEAKAGE CAN ONLY OCCUR IN AREAS WHERE THE SYSTEM IS UNDER A VACUUM - CIRCLED AREAS

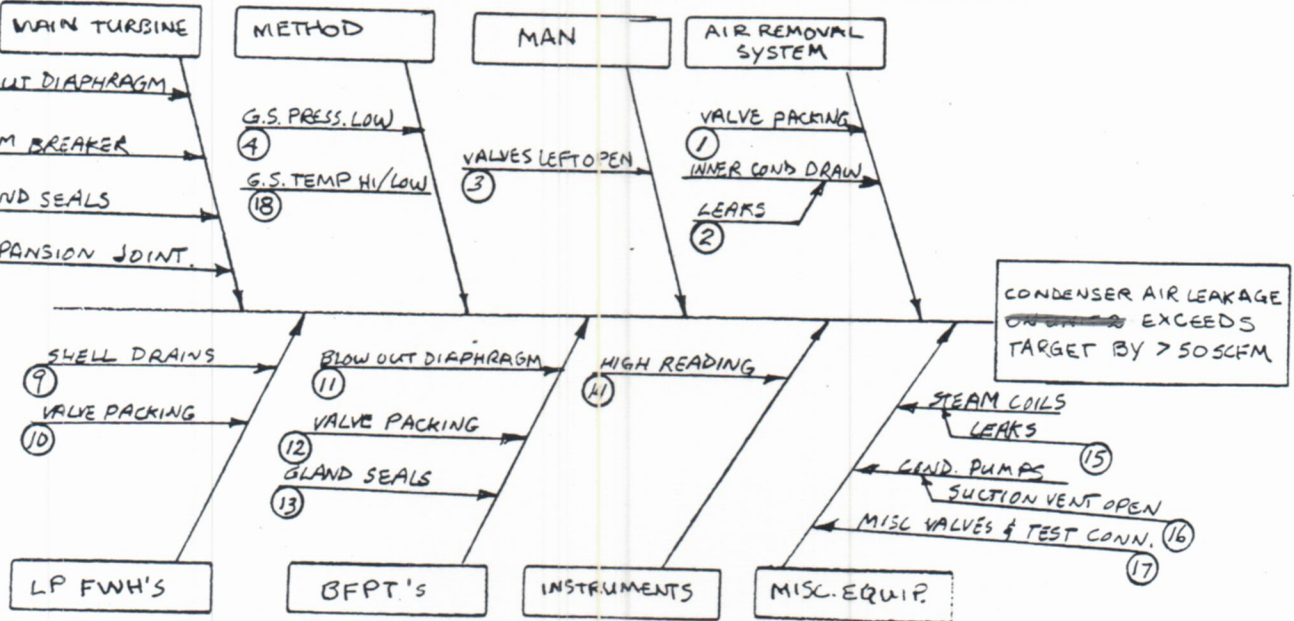
| 1 | NO LEAK VERIFIED WITH FREON DETECTION TECHNIQUE |
| 7 | CANNOT DISPROVE |
| 13 | CANNOT DISPROVE |
| 17 | CANNOT DISPROVE |

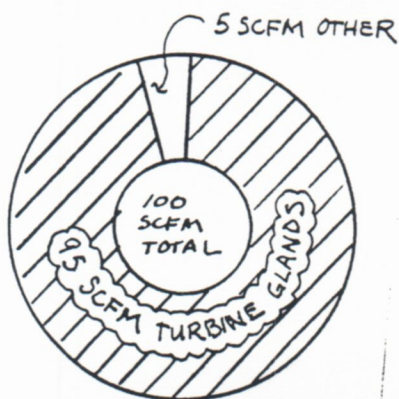
95% OF AIR INLEAKAGE IS THRU TURBINE GLANDS

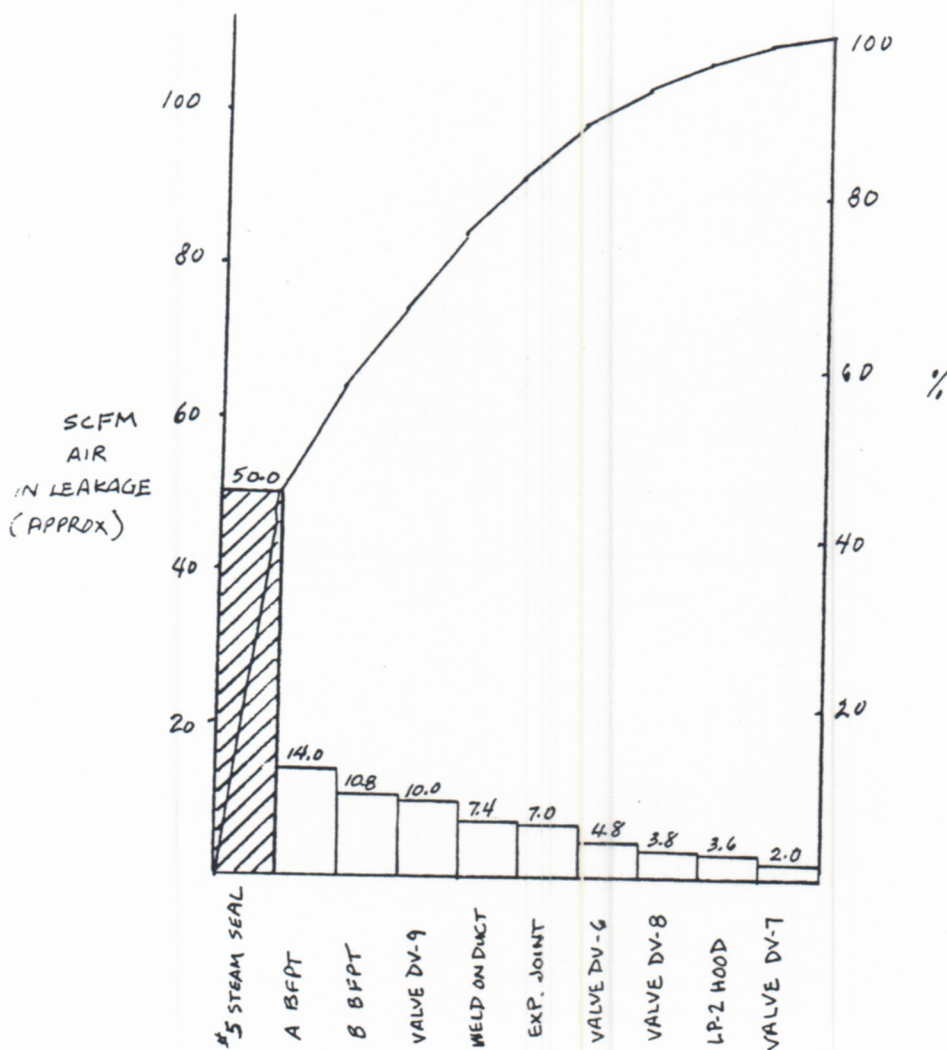
#5 STEAM SEAL HAS BY FAR THE MOST LEAKAGE.

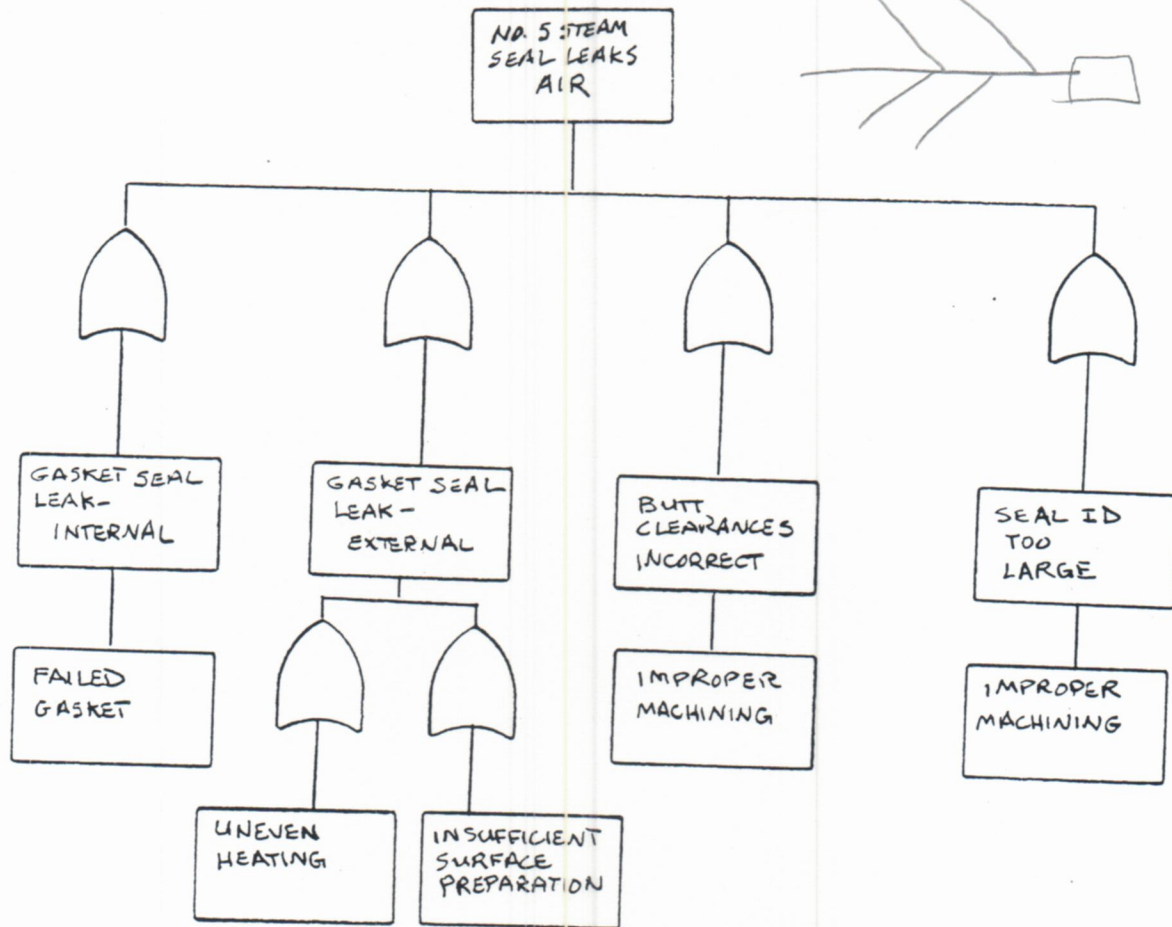
THE GASKET SEAL LEAKS - EXTERNAL COULD BE REMOVED FROM THE FAULT TREE BECAUSE THEY WERE STOPPED BY THE APPLICATION OF SEALANT. THE GASKET SEAL LEAKS - INTERNAL, THE BUTT CLEARANCES, AND THE SEAL ID ARE NORMALLY ONLY ABLE TO BE CHECKED DURING AN OVERHAUL. HOWEVER, AN IDEA FOR CHECKING FOR GASKET LEAKS - INTERNAL WAS TRIED.

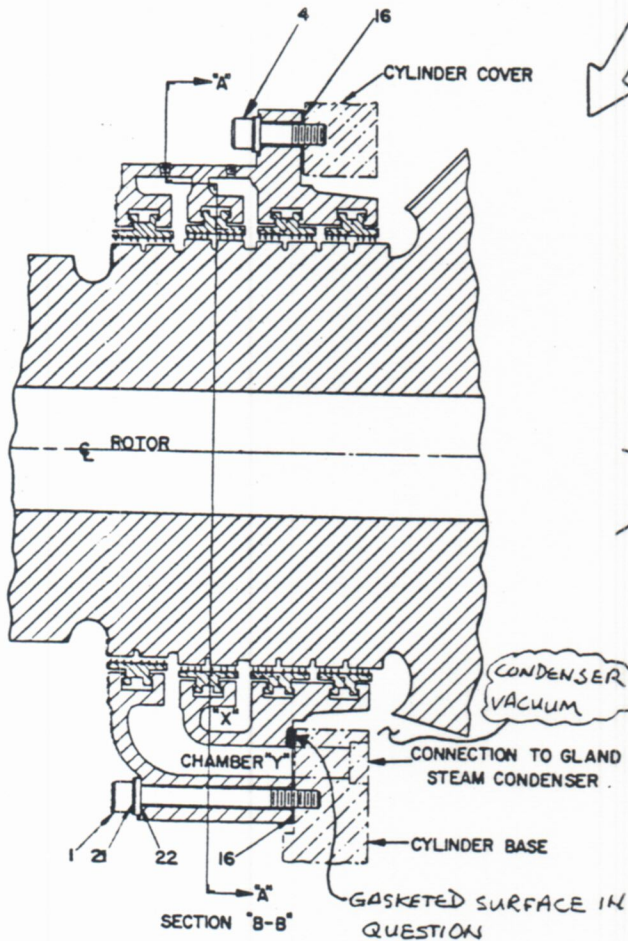
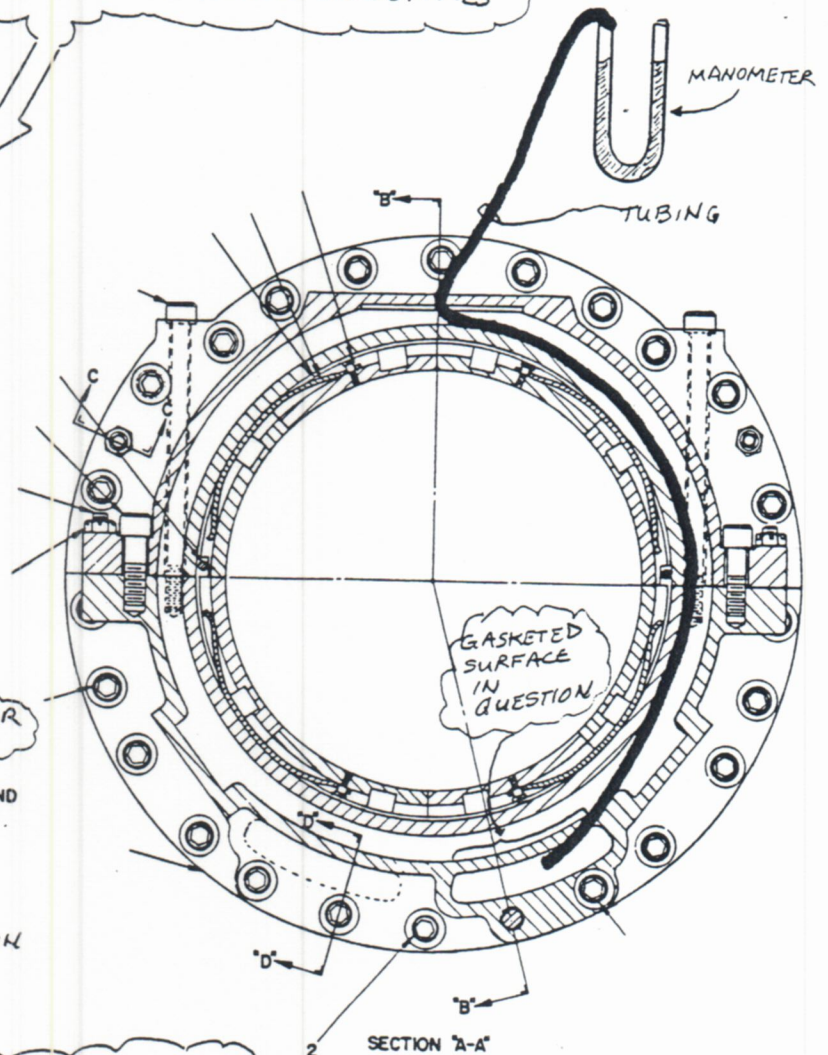
THROUGH BRAINSTORMING AN HYPOTHESIS WAS DEVELOPED THAT IF THE GASKET BETWEEN THE Y-CHAMBER AND THE FINAL TURBINE STAGE FAILED, CONDENSER VACUUM WOULD BE APPLIED TO THE STEAM SEAL BRUING IN LARGE QUANTITIES OF AIR.

TO PROVE THE HYPOTHESIS, A PIECE OF TUBING, CONNECTED TO A MANOMETER, WAS "SNAKED" INTO THE STEAM SEAL. WHEN IT REACHED THE GASKETED SURFACE IN QUESTION, ALL THE WATER WAS SUCKED OUT OF THE MANOMETER, INDICATING A VERY HIGH VACUUM AND THE PROBABILITY OF A FAILED GASKET

- ALL GASKETS BETWEEN X, Y CHAMBERS AND  
LAST TURBINE STAGE WERE FAILED (BLOWN OUT).
- THE SEAL ID'S WERE TOO LARGE RESULTING IN  
EXCESSIVE CLEARANCES TO SHAFT.
- ( ● NO. 8 GLAND SEALS HAD EXCESSIVE BUTT CLEARANCES. )

AN OVERHAUL WAS SCHEDULED TO INSPECT AND REPAIR THE SEALS

| PROBLEM | ROOT CAUSE | COUNTER-MEASURE | PRACTICAL METHOD | EFFECT-IVENESS | FEAS. | OVERALL | ACTION? |
|---|---|---|---|---|---|---|---|
| NO. 5 STEAM SEAL LEAKS AIR | GASKET FAILED (WRONG MAT'L) | CHANGE GASKET MATERIAL | CHANGE FROM FIBER TO STEEL GASKET | 5 | 5 | 25 | YES |
| | SEAL ID TOO LARGE | CHECK SEALS AFTER MACHINING | REVISE PROCEDURE | 2 | 5 | 10 | YES |

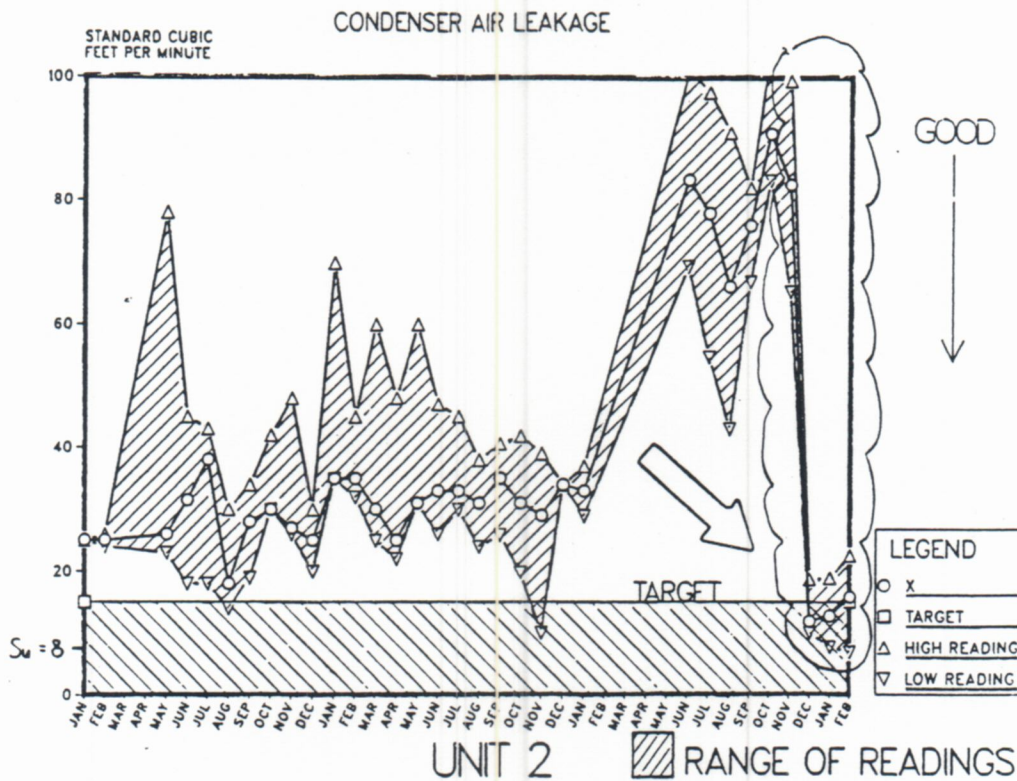
WHEN THE UNIT WAS RETURNED TO SERVICE,  
AIR LEAKAGE WAS DRAMATICALLY REDUCED  
FROM AN AVG. OF 82.4 SCFM IN NOV. TO  
11.8 IN DEC, 12.7 IN JAN, AND 15.8 IN FEB.

\* TWO BFPT AIR  
LEAKS IDENTIFIED
