## Theme: Elimination of Automatic Censor Lights Which Fail to Light Up at Night

| OFFICE LOCATION: | Instrument section, test center, distribution department. | | |
| PRESENTER: | Chosaki Koichi | Circle name: | Double Power |

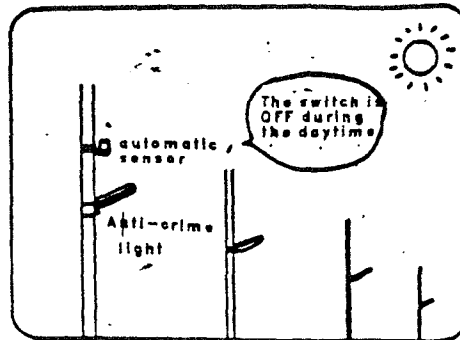
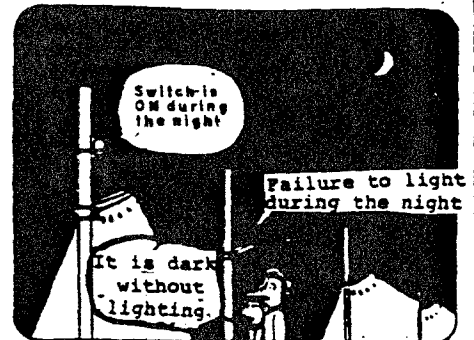
It is an automatic switch that shuts off during the day and turns on the anti-crime lights when evening illumination is lower than 20-5 lx.

The automatic censor that fails to turn on anti-crime lights during the night is called a "non-lighting unit".

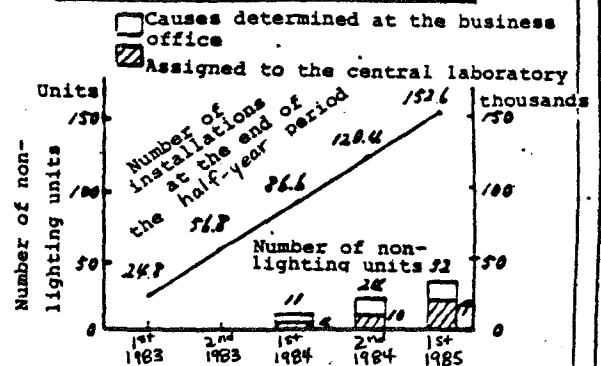
### Occurrence of non-lighting units

The number of automatic censor installations in ten years will be 1,440,000 (Increase in the number of anti-crime lights contract, 30,000/year; replacement of old line products, 100,000/year)

The number of non-lighting units increases along with the increase in the number of installations

In ten years, the number of cases with unknown cause will be  
 $10 \text{ (units/6 months)} \times 2 \times 1,440,000/152,600 = 190 \text{ (units/year)}$

If the present trend continues, there will be 190 non-lighting units each year whose causes are unknown

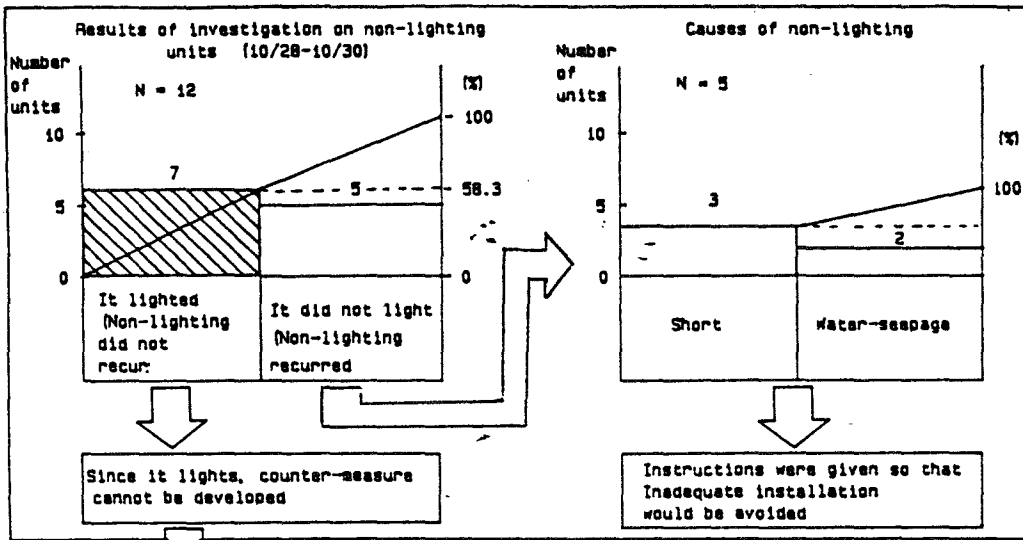
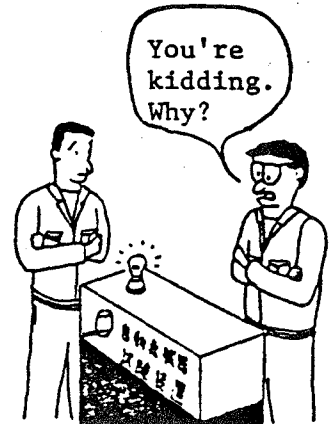
Investigation was conducted on 12 units that were brought in over the past three months prior to October, 1985.

Non-lighting did not recur.

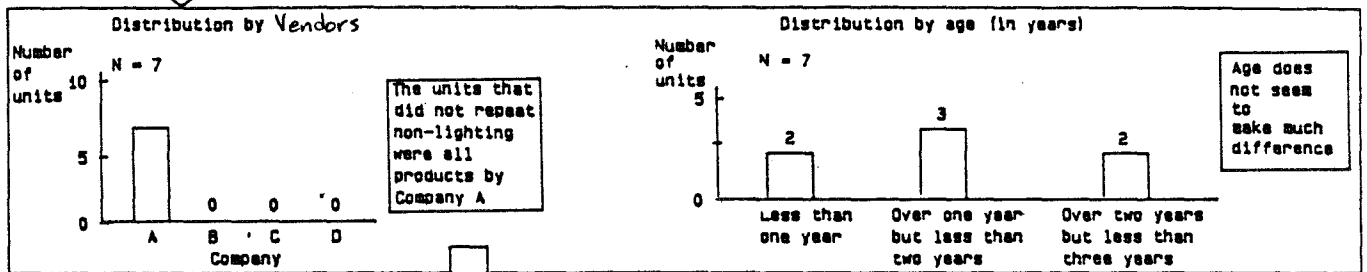
It is necessary to find the causes of non-lighting units made by Company A

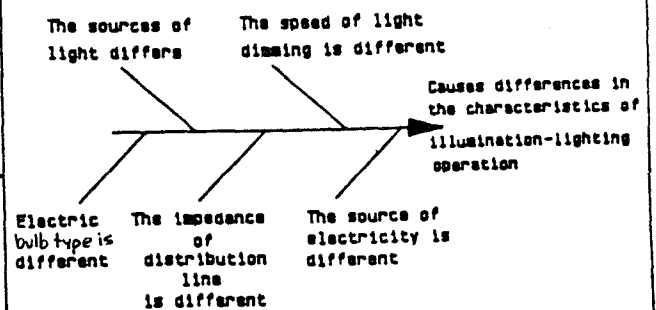
Characteristics causal diagram on "characteristics of illumination-lighting operation.

| Characteristics of automatic sensors | Relationship to non-lighting |
| 1. Insulating resistance characteristics | × |
| 2. Voltage withstanding characteristics | × |
| 3. Characteristics of illumination-lighting operation | ○ |
| 4. Characteristics of illumination-turning off operation | × |
| 5. Noise characteristics | × |

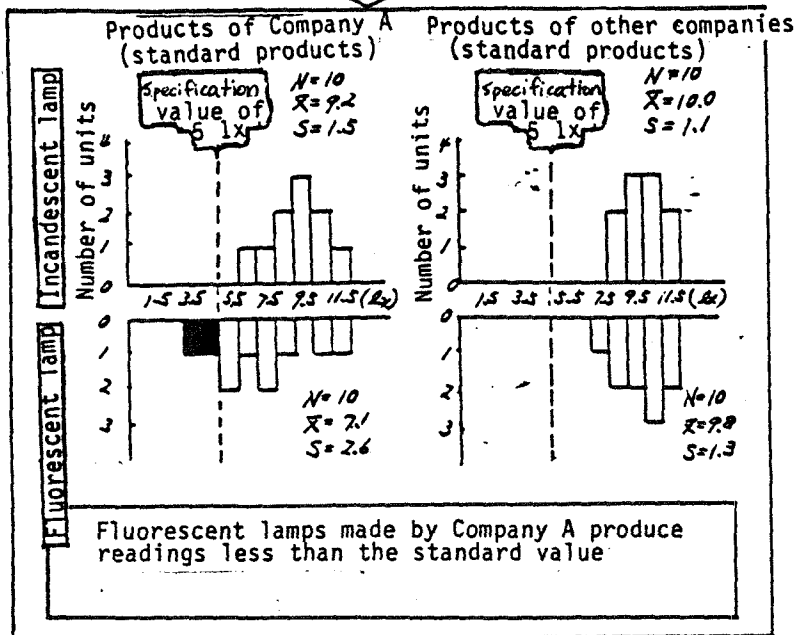
Measure nocturnal illumination in residential areas without anti-crime lighting

Each member of the team conducted measurements at ten different places in his neighborhood

The hypothesis, "the use of automatic censor made by Company A and fluorescent lamp in an area with high illumination results in failure to light at night", has been verified.

Notified and explained to the sales offices that "automatic censors made by Company A fail to light at night if night-time illumination is high around installation sites," and instructed them to reconsider installation sites
