## MECHANICAL MAINTENANCE FUNCTIONAL TEAM

| TEAM PROJECT PLANNING WORKSHEET | | | | | | | | | | | | | |
|---|---|---|---|---|---|---|---|---|---|---|---|---|---|
| Theme<br>(Problem Area) | | Unit #3 Feedwater Heater Failures | | | | | | | | | | | |

IN THE PAST 9 YEARS THERE HAVE BEEN 22  
LOAD CURTAILING DIAPHRAGM FAILURES ON HEATER #1  
THESE FAILURES SHOULD BE REDUCED TO A POINT  
WHERE THEY MEET OUR EFOR TARGET

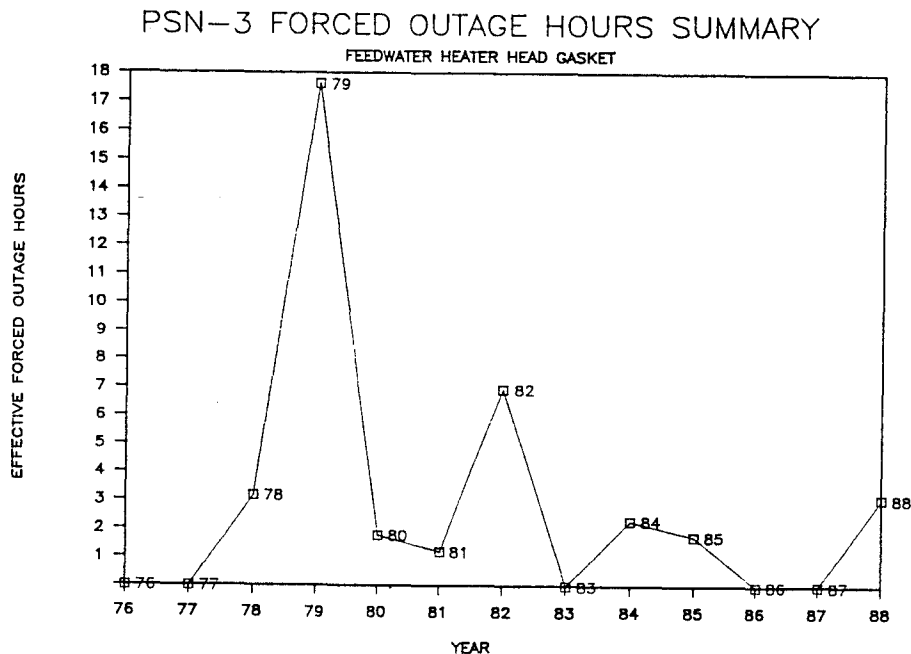
CAN WE MEET THE 50% REDUCTION IN HIGH PRESSURE FEEDWATER HEATER  
DIAPHRAGM FAILURES OUR CUSTOMER WANTS ?

$22 \text{ (\#1 FWH)} \div 32 \text{ (\#1 \& \#2 FWH)} = 69\%$   
 $\geq 90\%$  IMPROVEMENT IN #1 FWH FAILURES  
 WILL GIVE A 50% REDUCTION IN FWH  
 DIAPHRAGM FAILURES.

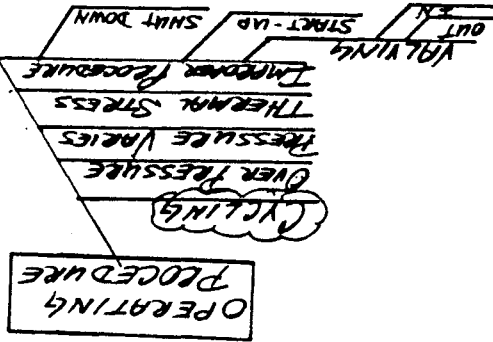
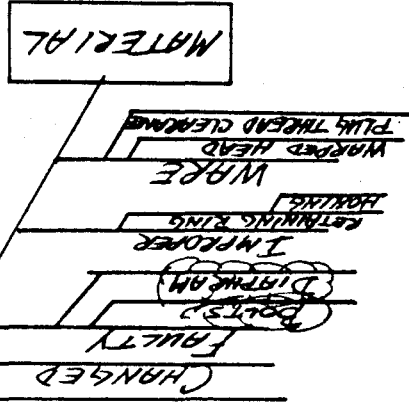
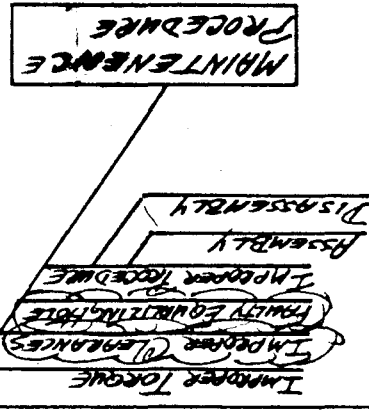
Possible Causes:  
 1. Pressure Differential  
 2. Warped Head  
 3. Improper Torque  
 4. Faulty Material  
 5. Material Change  
 6. Improper Procedure

7. Improper Clearances  
 8. Faulty Equalizing Hole  
 9. Over Pressure  
 10. Cycling  
 11. Improper Thread Clearance  
 12. Thermal Stress

IN THE PAST 9 YRS. THERE HAS BEEN 22 LOAD CURT-AILING DISINTEGRATIONS ON FWH #1. THESE FAILURES SHOULD BE RE-PAIRED TO A POINT OF BETTER RELIABILITY & DEFENDABILITY

Most Flexible Rod Causes:  
 1. Incorrect Diameter Material  
 2. Incorrect Bolt Length  
 3. Incorrect Interval Clearances  
 4. Equalizing Hole Plugged  
 5. Cycling Stress

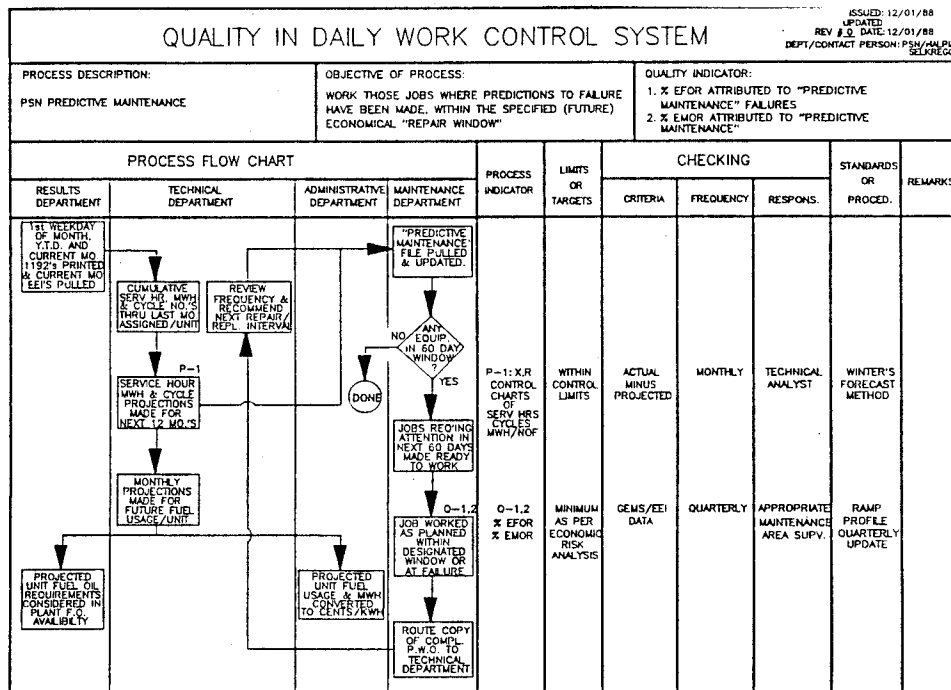
THERE ARE NO REMAINING PROBLEMS ON #1 F.W. HTR. THAT THE TEAM NEEDS TO WORK ON AT THIS TIME.

- 1.) THE ASSURANCE OF 2 DIAPHRAGMS INSTALLED
  - 2.) NOTING CONDITION OF DIAPHRAGMS AS FOUND AND DOCUMENTING LOCATION OF FAILURE.
  - 3.) INSTALLATION PROCEDURE FOR NEW STYLE TUBE PLUGS. THIS PLUG USES A SWEDGE METHOD TO INSTALL INSTEAD OF WELDING.
- THESE CHANGES HAVE BEEN IMPLEMENTED. ✓22

EVERYTHING HAS BEEN REPLICATED ON #2 F.W. HEATER. NO OTHER REPLICATION POSSIBLE. ✓23
