# CASE: AIR LEAKAGE TO A POWER PLANT CONDENSER

## IDENTIFY AN IMPROVEMENT OPPORTUNITY

THE DAVIS POINT THERMAL POWER PLANT SUPPLIES UP TO 440 MEGAWATTS OF ELECTRIC POWER TO THE SINGLETON ELECTRIC + LIGHT COMPANY'S TRANSMISSION SYSTEM. (SEL)

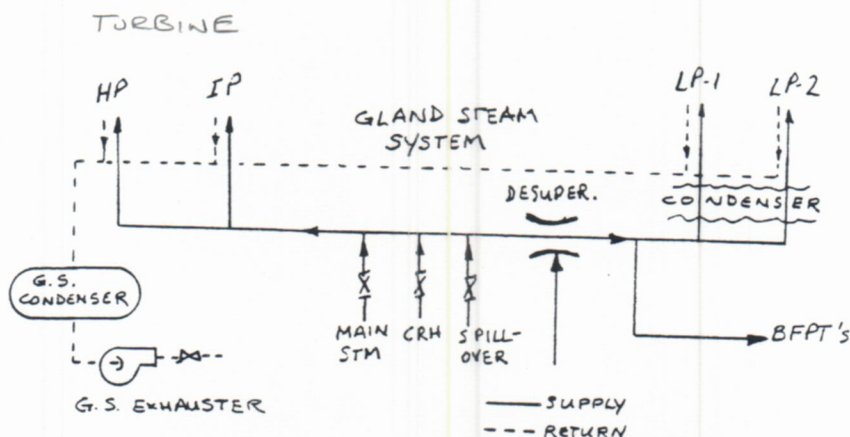
CONSIDER THE GLAND STEAM SYSTEM:

IF THE GLAND STEAM SUPPLY PRESSURE WAS RAISED VERY HIGH AND THE EXHAUSTER TURNED OFF, STEAM WOULD BE FORCED OUT THE SEALS, TEMPORARILY STOPPING ANY AIR INLEAKAGE THRU THE SEALS. THUS THE CONTRIBUTION OF THE SEALS TO AIR INLEAKAGE COULD BE MEASURED. (HP & IP SEALS CAN BE IGNORED SINCE THERE IS NO PATH TO CONDENSER)

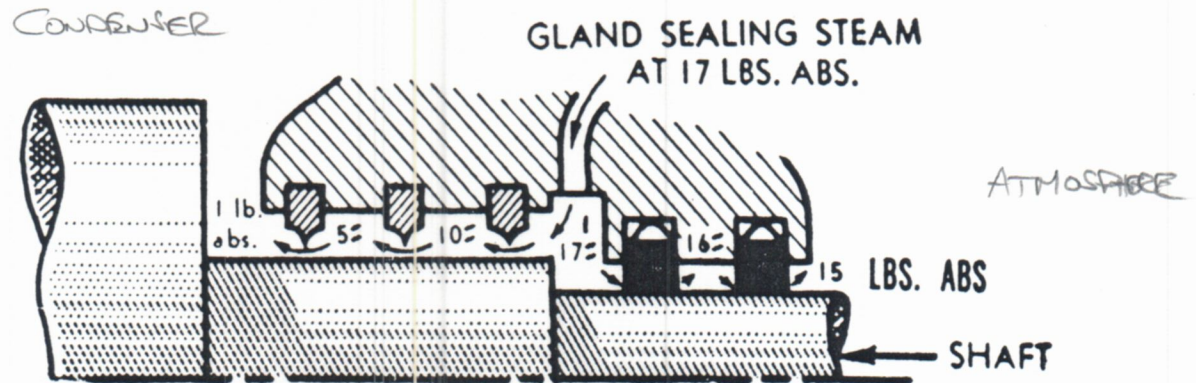
**FIG. 3-11. Turbine Gland with Low Pressure in Turbine.**

shows diagrammatically a turbine gland seal in its simplest form.

Steam at about 2 p.s.i., gauge, (17 p.s.i.a.) is led into a space between two sets of gland packing. As its pressure is greater than the atmosphere and the pressure inside of the turbine, the gland steam flows both into the casing and out into the engine-room thus positively excluding all air from the turbine.

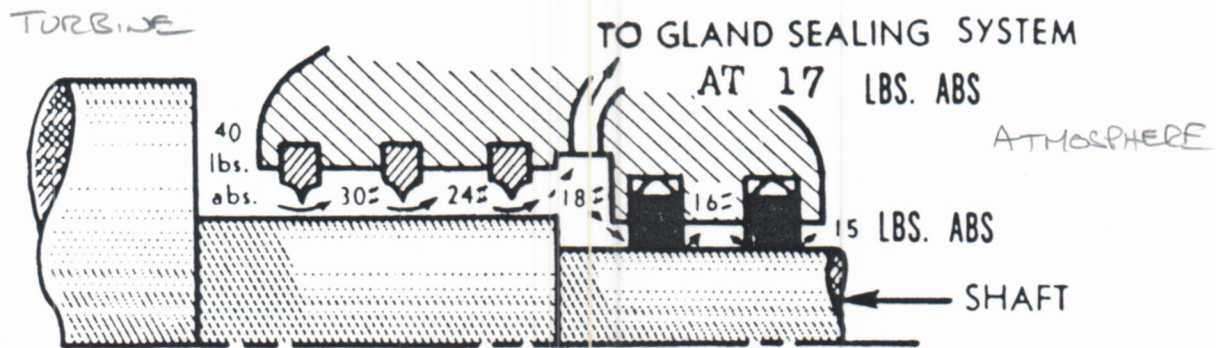
FIG. 3-12. Turbine Gland with High Pressure in Turbine.

both ends of the low pressure turbine the pressure is below atmospheric. Suppose now that in *Fig. 3-11* the pressure inside the turbine, instead of being 1 p.s.i.a., is 40 p.s.i.a. and, after having passed through the labyrinth packing into the chamber where the gland steam is admitted, its pressure has been reduced to 18 p.s.i.a. The steam will then flow in two directions as shown in *Fig. 3-12*. Part of it will continue to flow out of the turbine gland through the carbon packing, but most of it, being at a higher pressure than the gland sealing steam, will flow into the gland sealing connection reversing the direction of the gland steam. It is usual for the gland sealing line to be closed at such times in which case a gland leak-off connection is provided to lead the excess steam to a lower stage or to the condenser.
